# Home Inspection Report

57647 Cedar Springs Dr., Scappoose, OR 97056

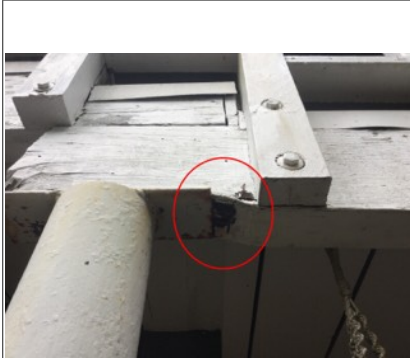
Recommend repairing rotted wood on exterior walk to laundry room

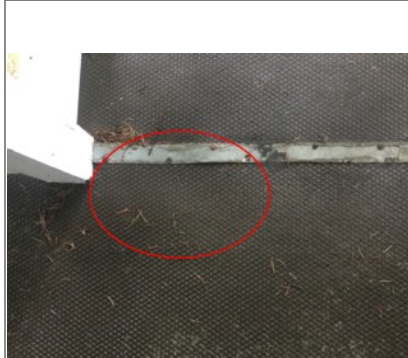
Recommend repairing rotted wood flooring where the walk meets the deck.

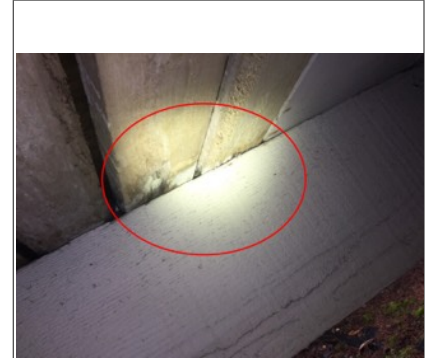
Wood walks and deck flooring has some moisture damage/rot. Recommend further evaluation and repair by a qualified contractor

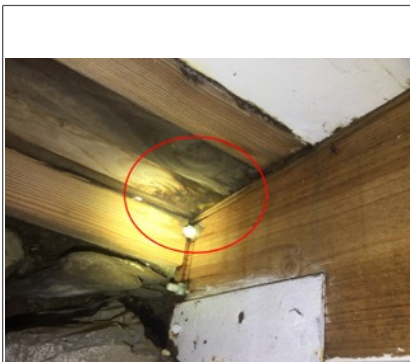
Recommend replacing rotted wood on deck/walks

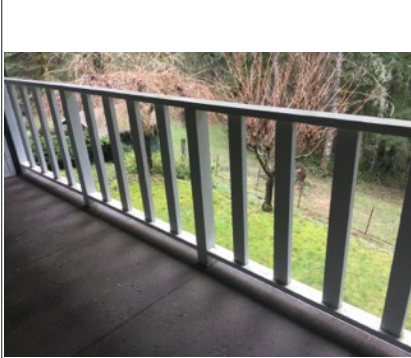
Balusters too far apart, for additional safety recommend balusters be a maximum of 4" apart - safety concern for small children.

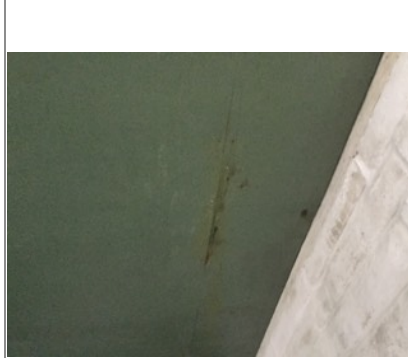
Roof leaking at chimney flashings. Recommend further evaluation and repair by a licensed and qualified roofer

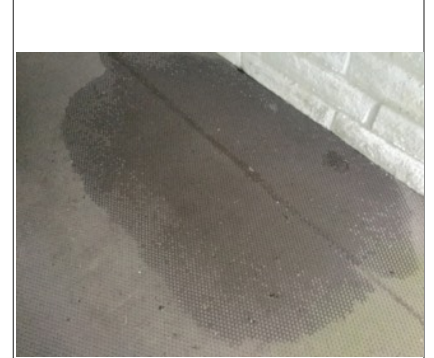
Evidence of roof leaking at chimney

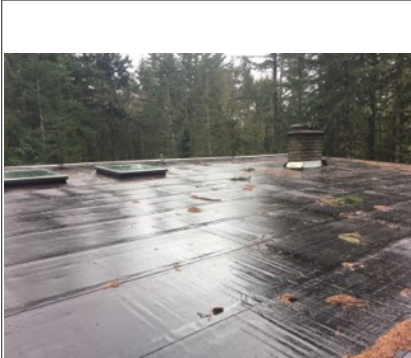
Roof covering was leaking and in need of repair. Recommend further evaluation and repair by a licensed and qualified roofer familiar with this type roof

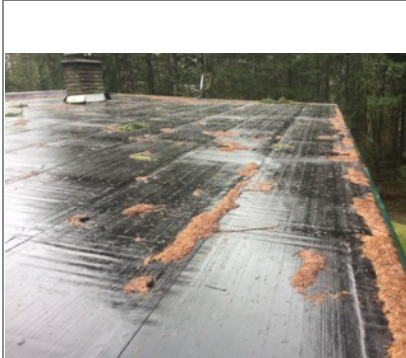
Roof covering on the North appeared to be newer and roof covering on the South appeared to be nearing the end of its useful life. Roof covering was leaking. Recommend evaluation by a qualified roofer for repair of the leaking and possible replacement of the South half.

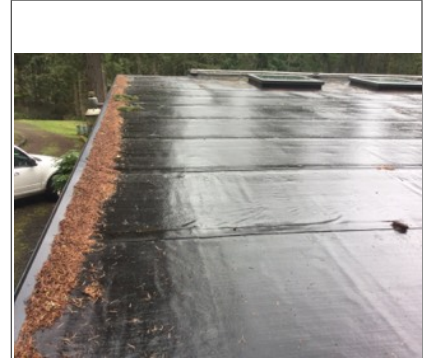
Recommend keeping debris off the roof covering to prevent pooling/standing water on the roof

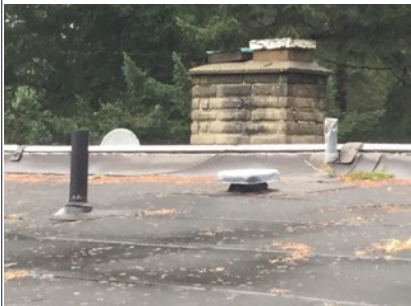
Roof covering was leaking around the chimney and several other areas. Recommend further evaluation and repair by a licensed and qualified roofer

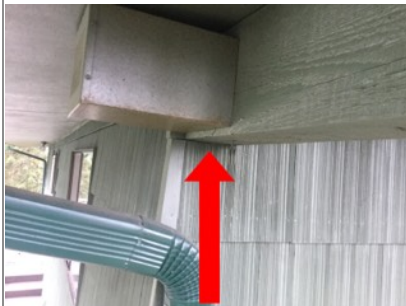
Roof structure is cantilevered, monitor for water penetration.

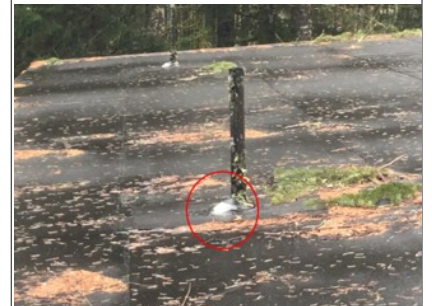
Excessive tarring of roof penetrations. Will require and ongoing maintenance to prevent leaks

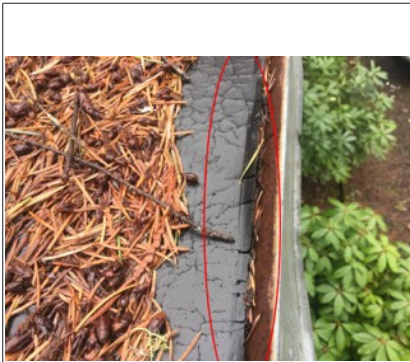
South roof covering was showing aging/wear and cracking. Recommend evaluation for possible replacement by a qualified roofer

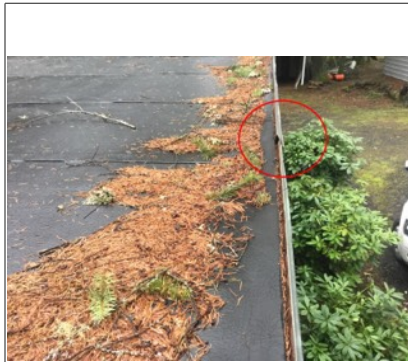
Drip edge flashings and chimney flashings pulling away in several areas. Recommend further evaluation and repair by a licensed roofer

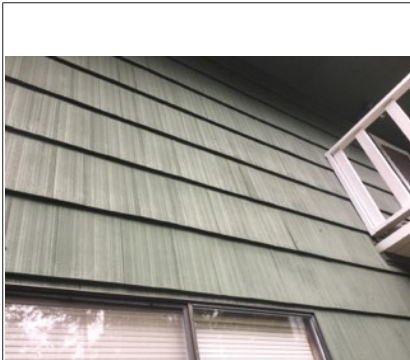
Siding was showing normal aging/wear, but was in overall adequate condition

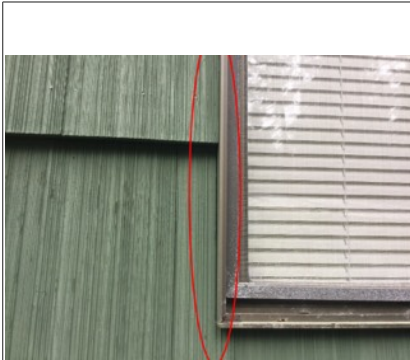
Recommend keeping up with the caulking maintenance around windows, doors, corners, trim, siding seams, and utility penetrations to prevent moisture intrusion

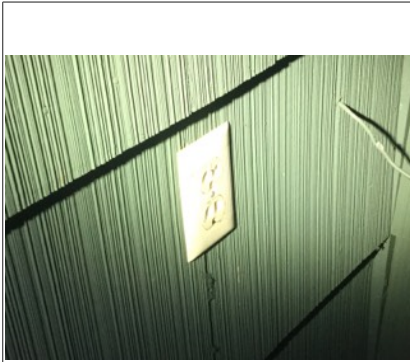
Missing weather covers and no overload GFCI protection on the exterior. -safety issue

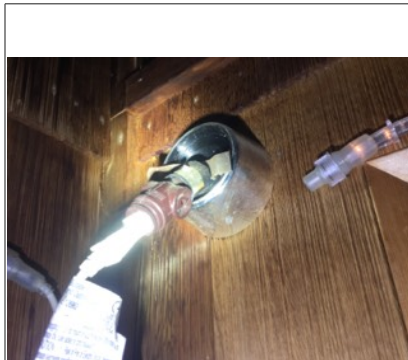
Potential safety hazard in atrium electrical fixture. Recommend use caution

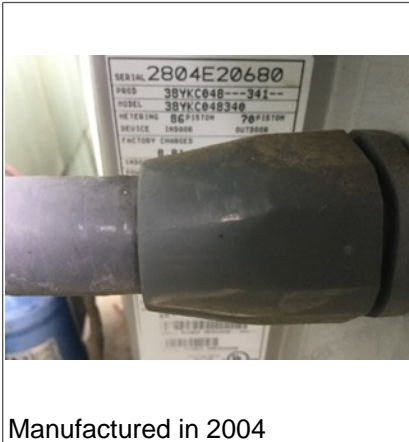
## Exterior A/C - Heat pump #2

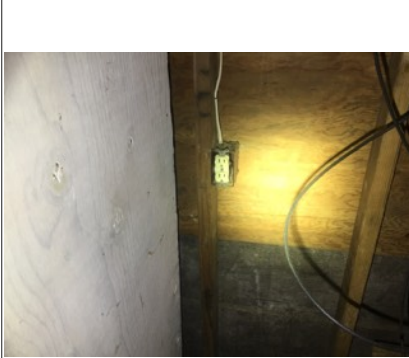
Missing outlet covers and no overload GFCI protection in the garage. -safety issue

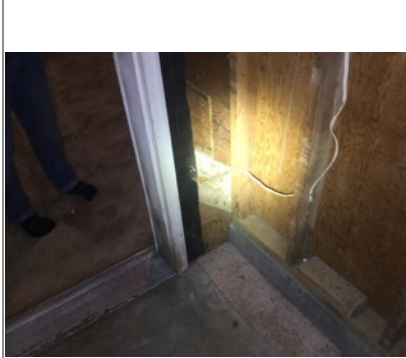
Missing fire rated separation wall between garage and living space. -potential safety issue

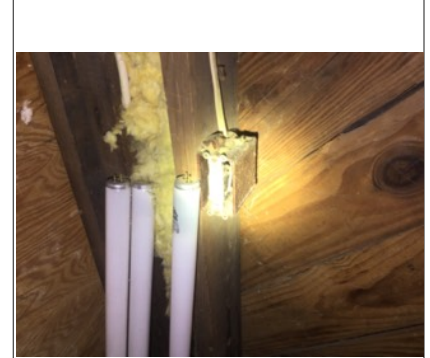
Several missing outlet and switch covers in the garage. -safety hazard

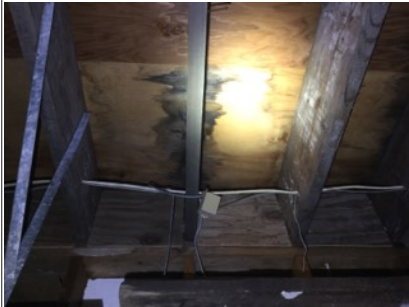
Moisture staining in the garage ceiling. Didn't appear to be active at the time of inspection. Recommend monitoring and repair as needed

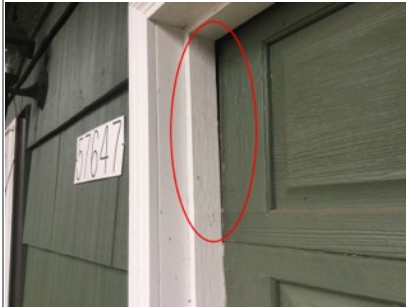
Missing weather stripping

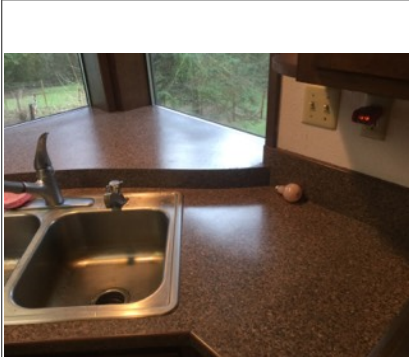
No overload GFCI protection in the kitchen within 6 feet of the sink

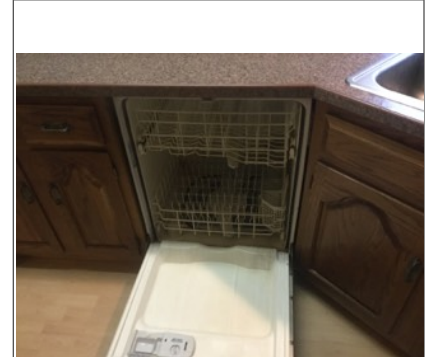
Dishwasher was older, but operating at the time of inspection. Also, there was moisture staining on the ceiling of the basement room below the dishwasher. Possibly due to leaking. Recommend monitoring and further evaluation and repair as needed by a qualified contractor

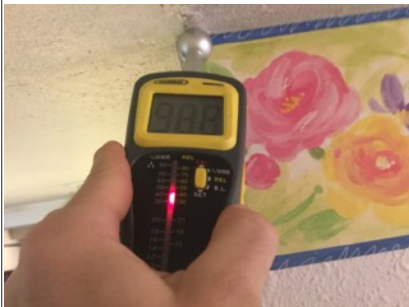
Evidence of active moisture/roof leaking in the kitchen. Recommend further evaluation and repair by a licensed and qualified roofer. Potential for concealed damage

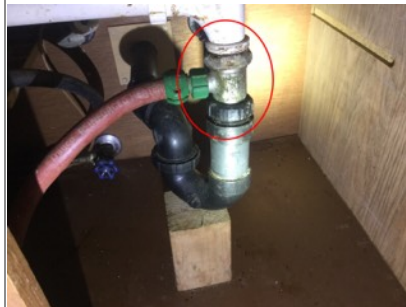
Galvanized drains under the kitchen sink corroded. Recommend monitoring

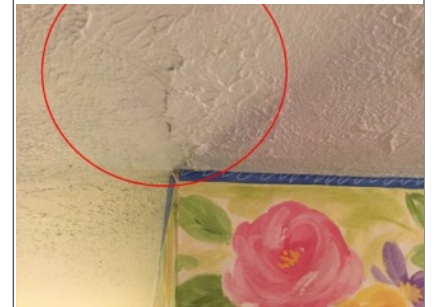
Evidence of roof leaking and repairs in the kitchen.

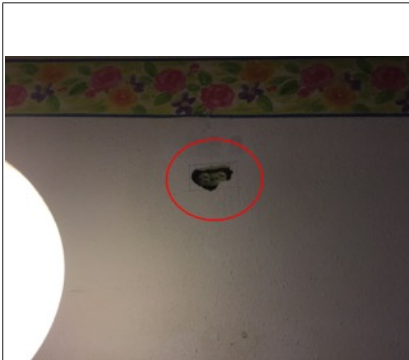
Improper electrical outlet in the kitchen wall.

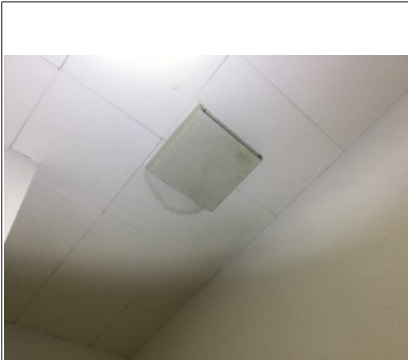
Moisture stains in the ceiling of the master bathroom. Roof covering was leaking in several areas. Recommend further evaluation and repair by a qualified roofer

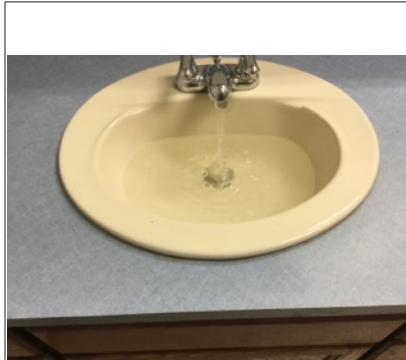
Marginal sink drainage. Possible clogged drain trap. Recommend further evaluation and repair by a licensed plumber

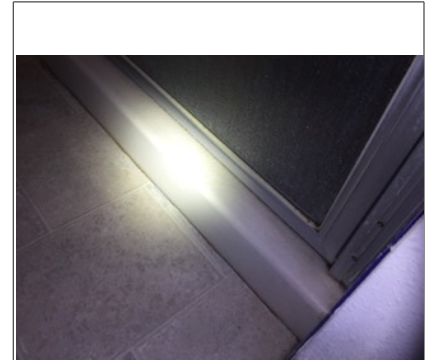
Recommend caulking at the shower to floor junction to prevent moisture intrusion

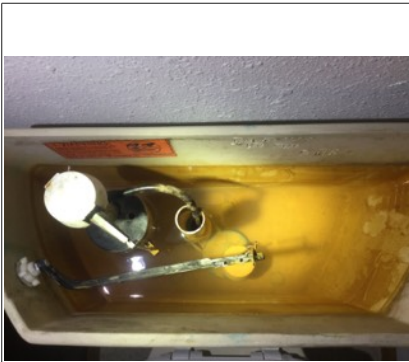
Several worn flushing mechanisms and flapper valves. Recommend replace as needed

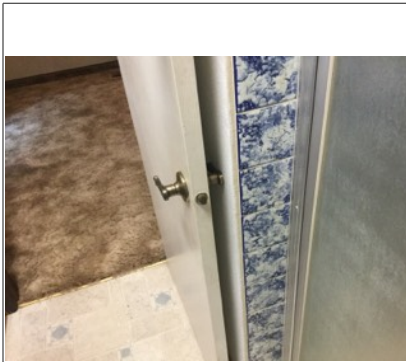
Several missing door stops, poorly operating door knobs, and missing privacy locks

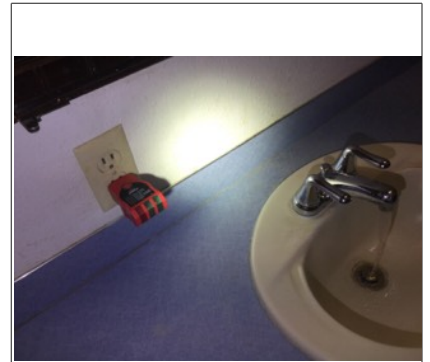
No overload GFCI protection in the bathrooms within 6 feet of the sinks. -safety issue

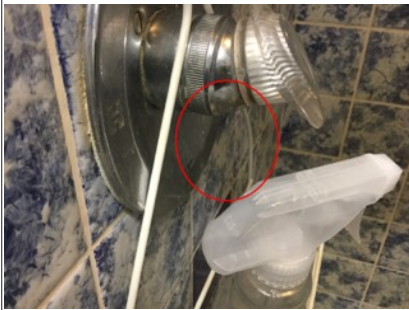
Master shower operating valve was leaking while shower was in use. Recommend further evaluation and repair by a qualified plumber

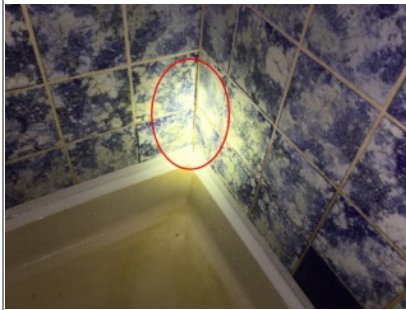
Recommend grout maintenance at the shower surround to prevent moisture intrusion

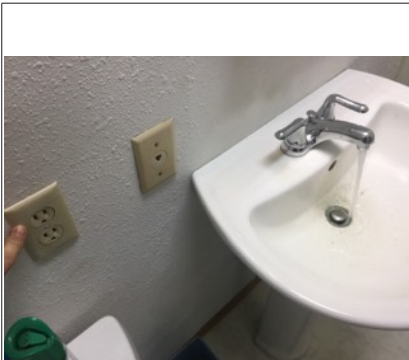
No overload GFCI protection in the bathrooms. -safety hazard

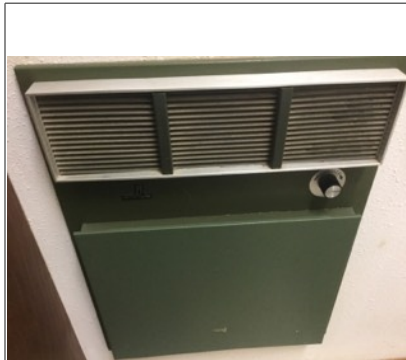
Heaters in bathrooms were in marginal condition.

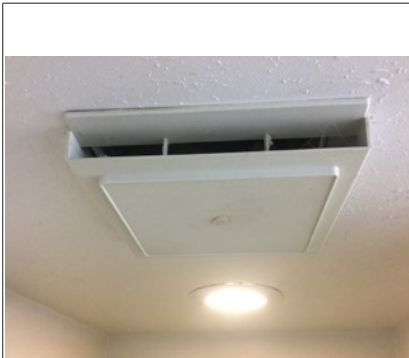
Bathroom exhaust fan was making loud bearing noises and maybe nearing the end of its useful life. Recommend replace as needed

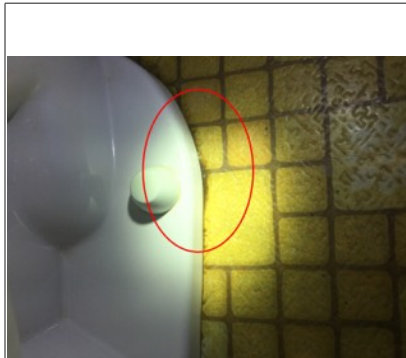
Basement toilet was leaking. Recommend further evaluation and repair by a qualified plumber

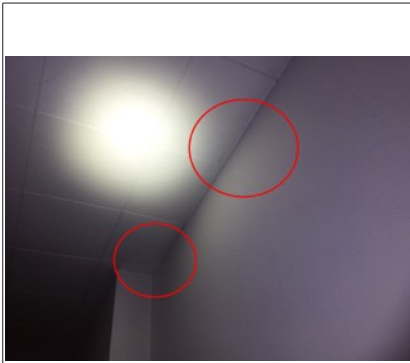
Moisture staining in the ceiling

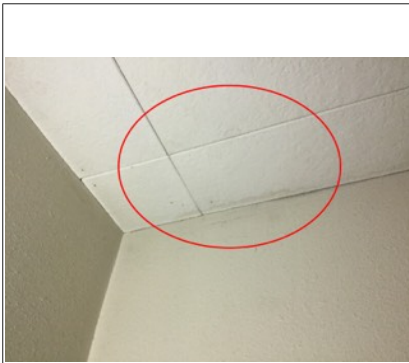
Moisture staining in the ceiling

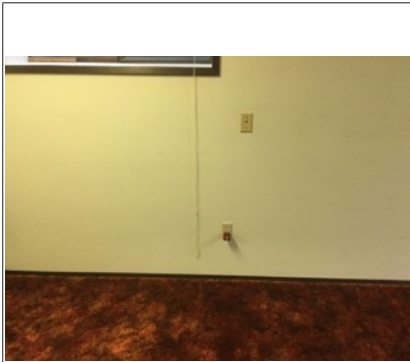
Open ground in the bonus room near the kitchen. -safety hazard

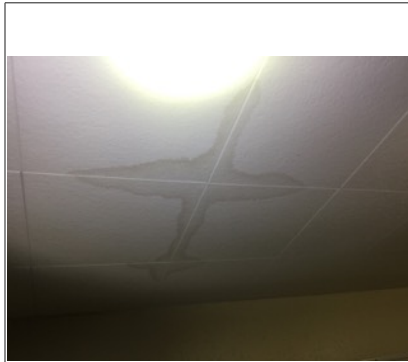
Moisture staining under the washing machine. Recommend drip tray be installed under washing machine

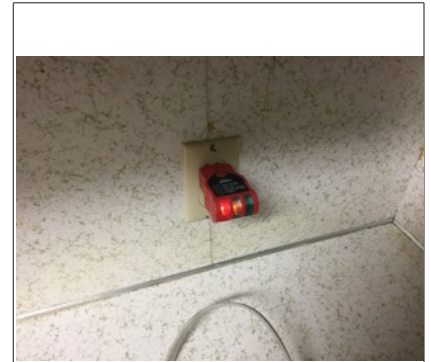
Reversed polarity and no overload GFCI protection in the basement kitchen within 6 feet of the sink. Safety issue

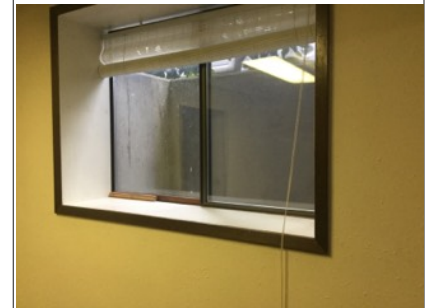
It is estimated that at some point moisture may make its way through most basement floors me/or walls. Recommend monitoring

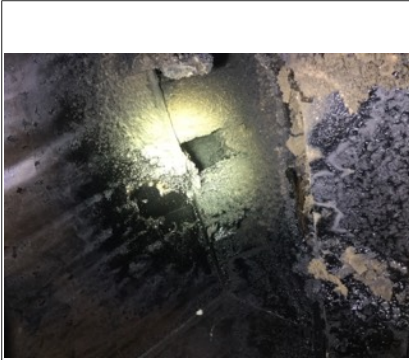
Creosote in chimneys.  
Recommend cleaning and re-evaluation by a licensed and qualified chimney sweep before using

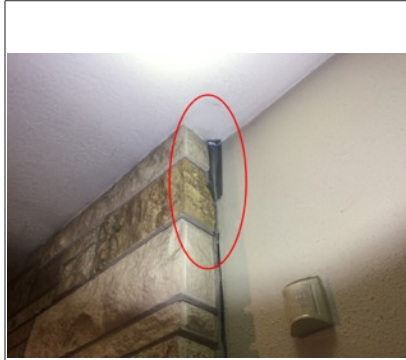
Recommend properly sealing the wall junction and fireplace surround.

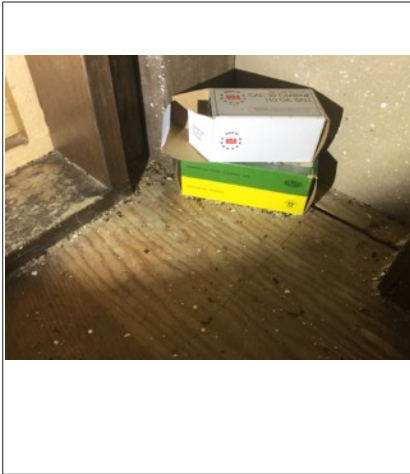
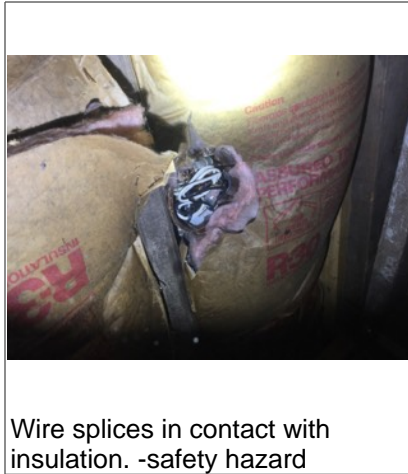
Wire splices in contact with insulation. -safety hazard

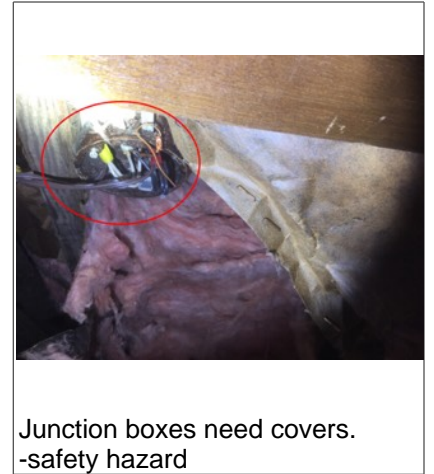
Junction boxes need covers. -safety hazard

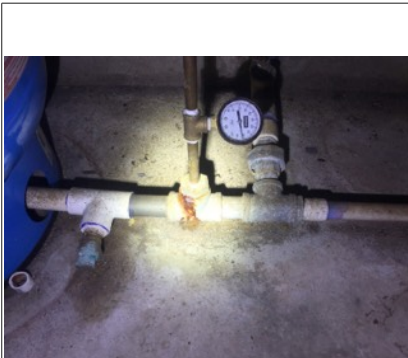
Water piping from pump rusted and leaking/seeping. Recommend further evaluation and repair by a qualified plumber. Also, pressure appeared to be over 80 psi. Recommend evaluation and repair as needed

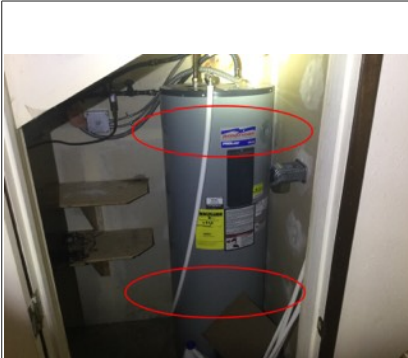
Missing seismic straps. -safety issue

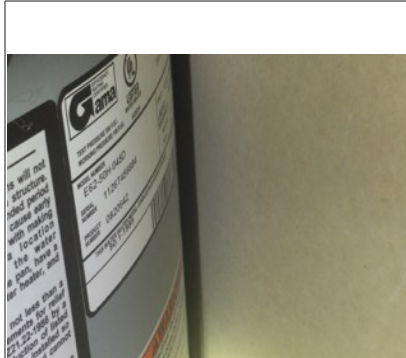
Manufactured in 2001. Electric water heater 50 gallon capacity

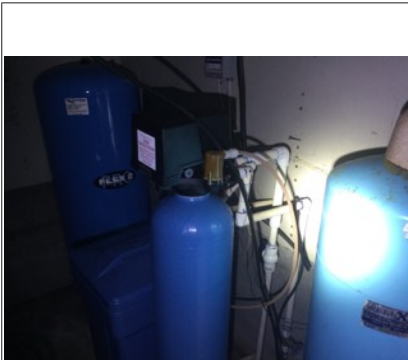
Recommend inquiring with the sellers about the water softener maintenance. Sulfur smell on the interior possible due to maintenance needed

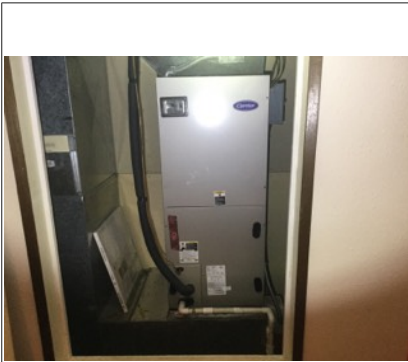
Heat pump was in normal operating condition. Recommend servicing by a licensed and qualified HVAC condition

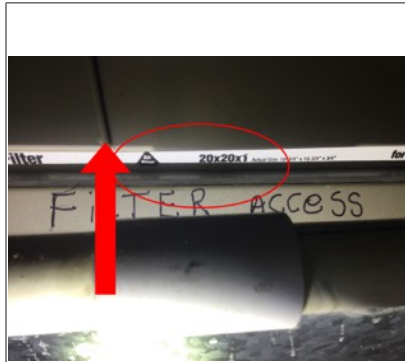
20x20x1  
Please note the direction of air flow

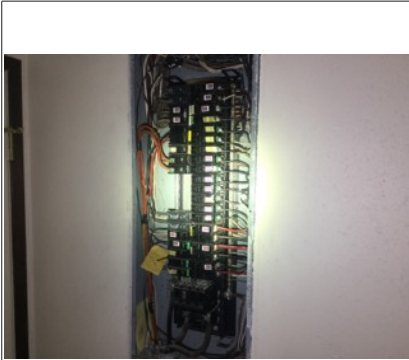
200 amp service. 120/240 V.  
 Proper breaker distribution.  
 Aluminum service wires. Copper  
 distribution wires. No visible signs  
 of overheating or scorching at the  
 time of inspection

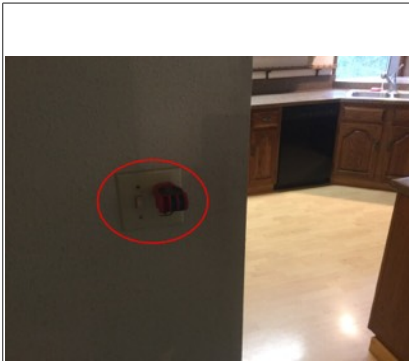
Outlet not operating. Recommend further evaluation and repair by a qualified electrician

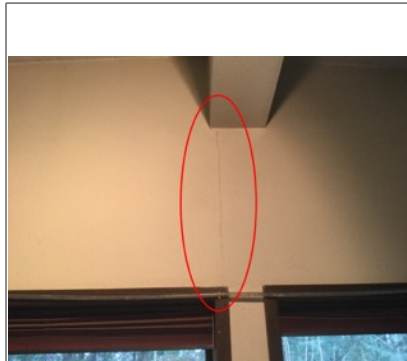
Typical interior ceiling and wall settling cracks. Recommend repair and monitoring for future movement/expansion

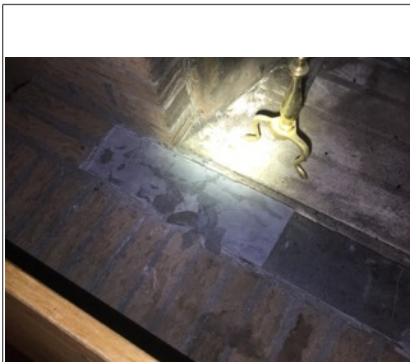
Damaged tile on fireplace Heath

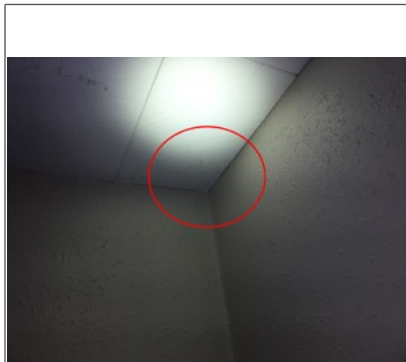
Ceiling has staining
